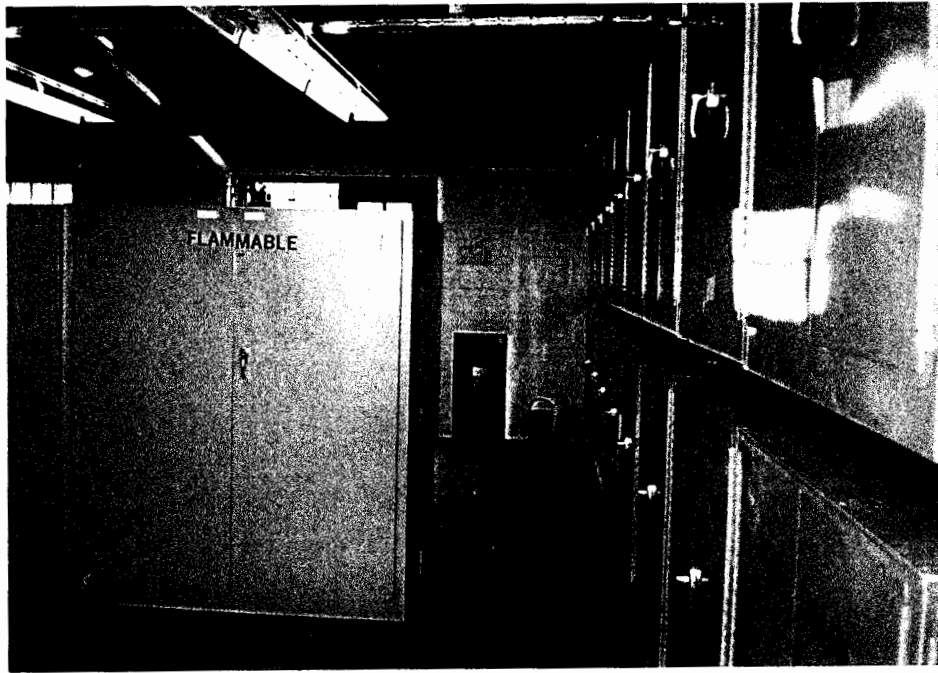
52.1 Laboratory Waste Accumulation Building. View of the indoor waste accumulation area for the Research and Development Laboratory.

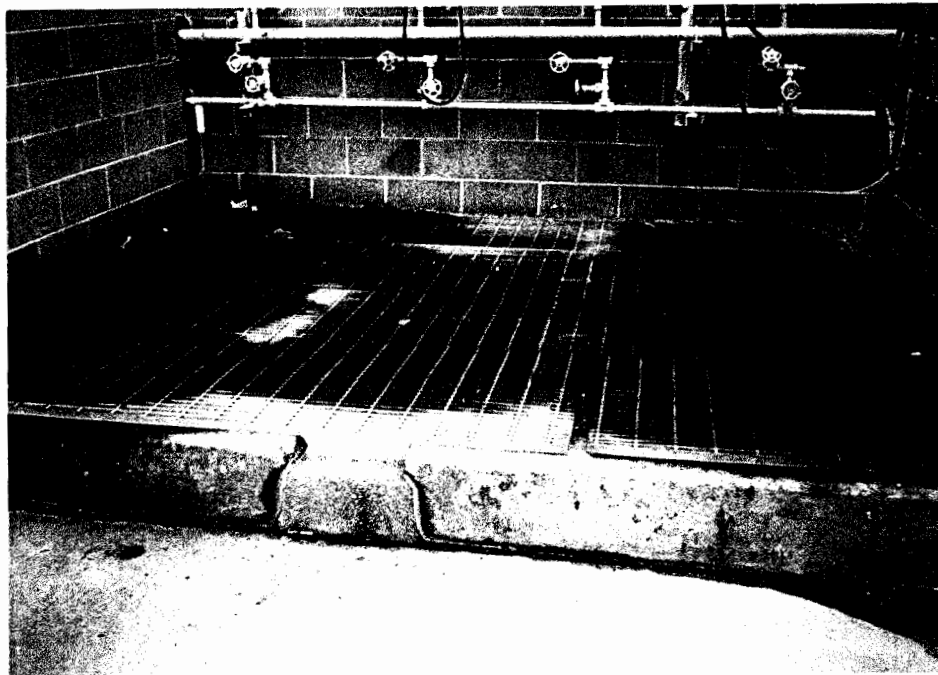
53.1 8-C Crude Unit Drip Showers. View facing west. Formerly, drums of carbon disulfide were cooled in the unit (one of four compartments). The grate covers a sump for the shower.

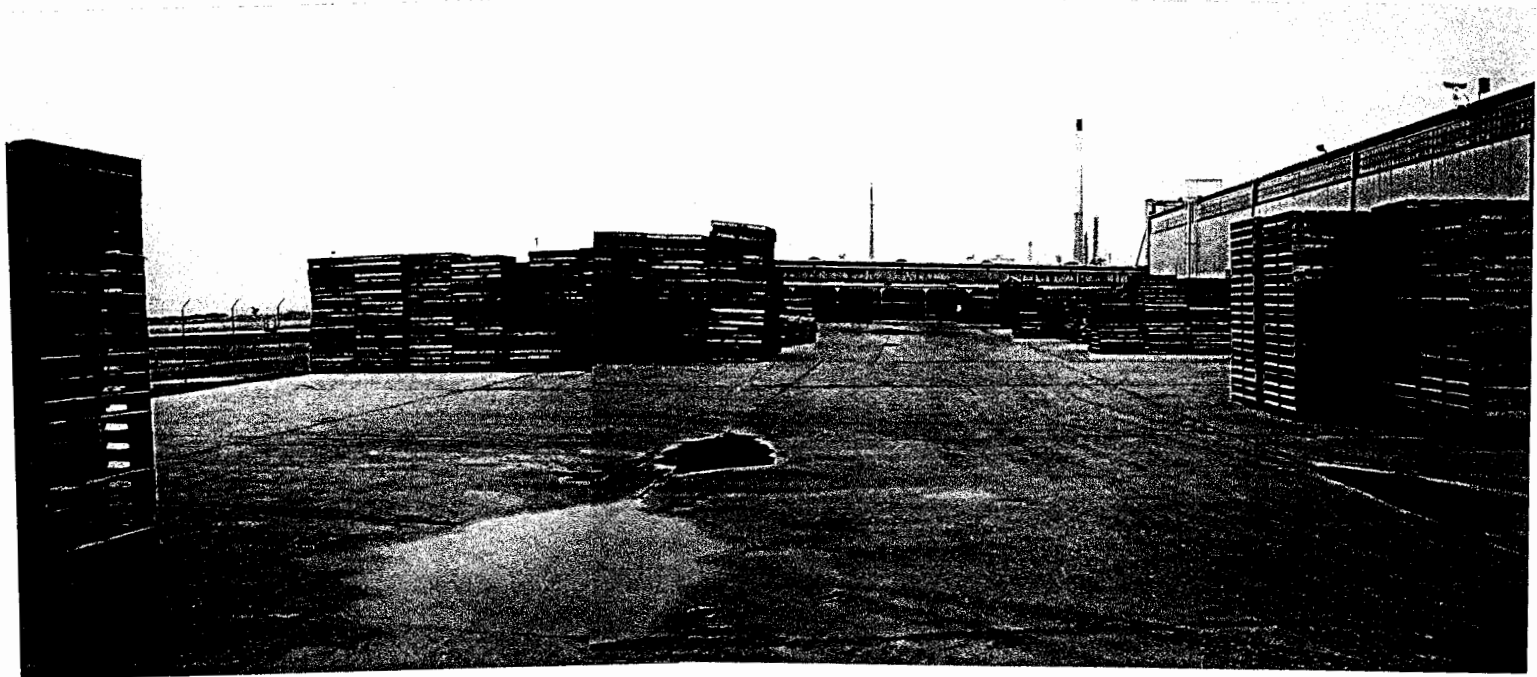
54.1 B & P Warehouse Drum Loading Area. View facing west. The unit is adjacent to the Lube Service Center and extends to the fenced area in the background of the photograph.

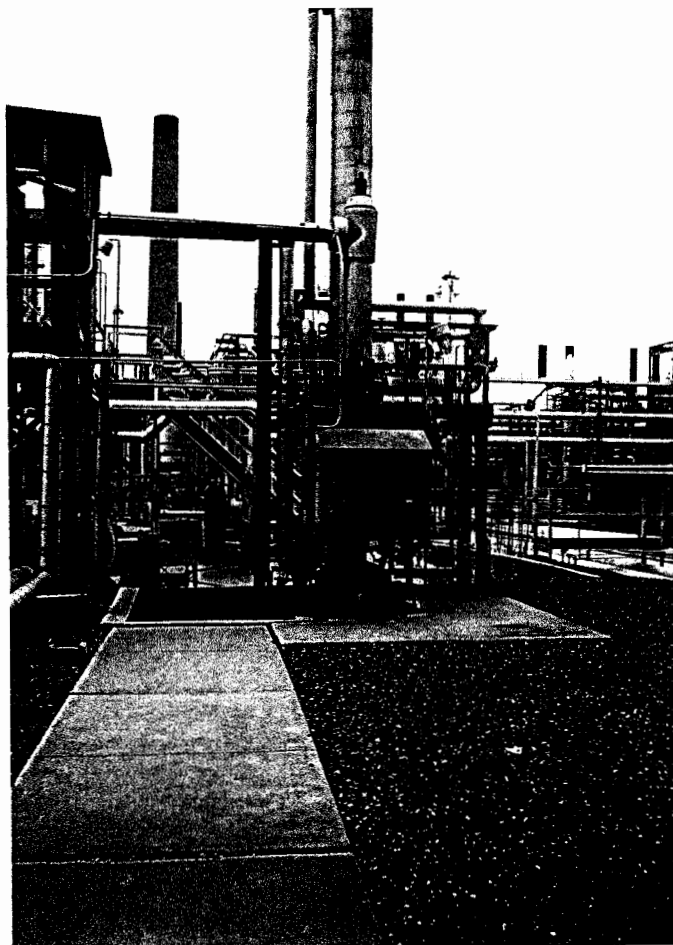
55.1 Benzene Vapor Recovery System. View facing south. The unit
is in the 17 Plant area.

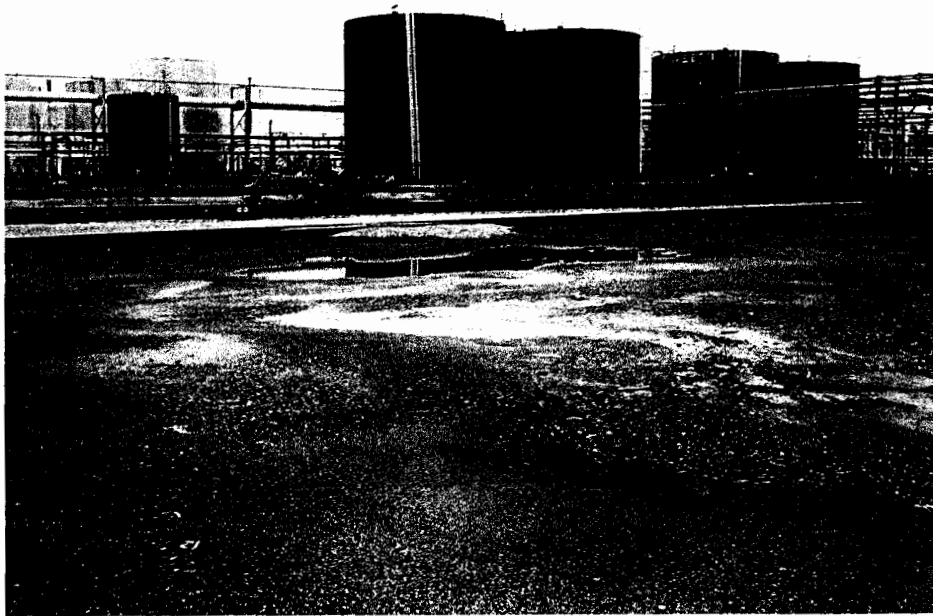
56.5 Asphalt Plant Area. Overview facing north showing the abandoned tanks at the old asphalt plant.

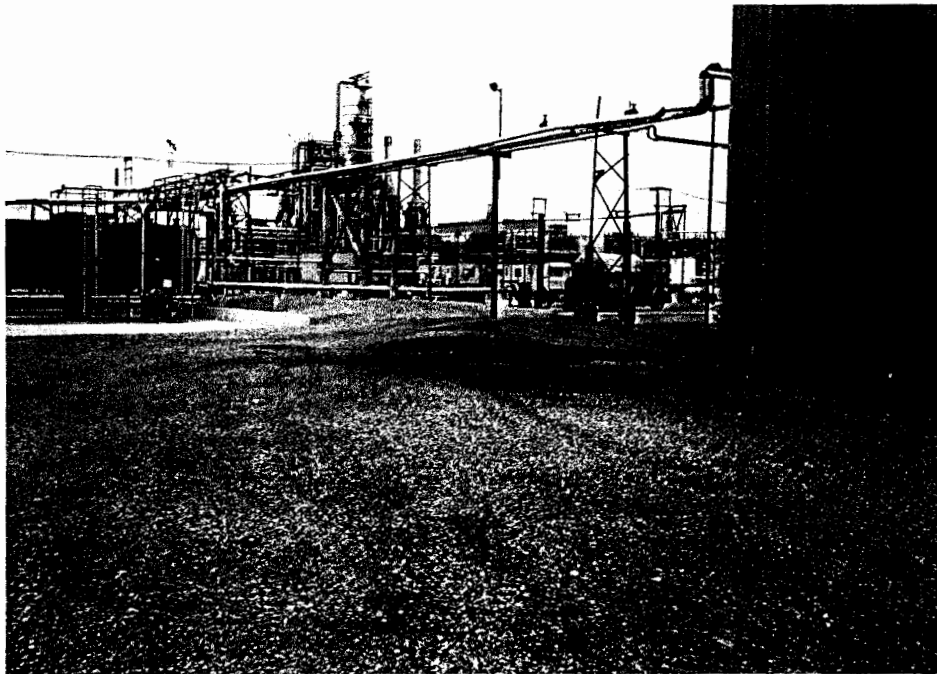
58.1 Slop Oil Tank V-29 View showing a South Jersey Pollution Control, Inc. vacuum truck loading slop oil into Slop Oil Tank V-29. The oil is piped from V-29 to Slop Oil Tank 132 (SWMU 59). Tank V-29 is the black railroad tanker car to the left. The concrete pad and curbing provide secondary containment for the unit. The staining on the ground is associated with the large storage tank on the right.

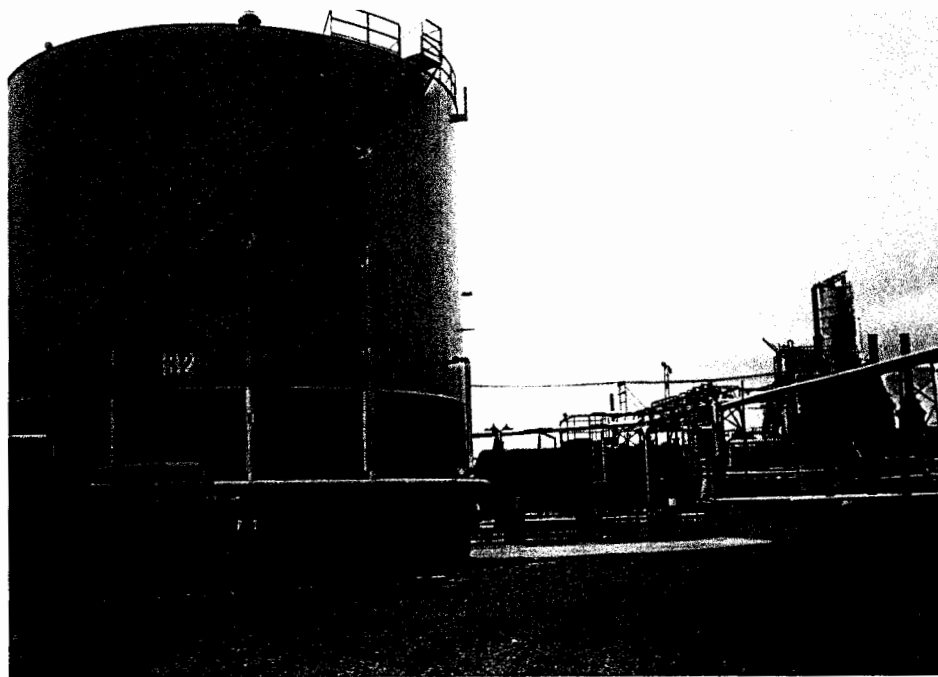
- 58.2 Slop Oil Tank V-29 and Slop Oil Tank 132. View facing
59.1 north toward the slop tank area. Tank 132 is in the
 foreground of the photograph. Tank V-29 is the black tanker
 car visible to the right of Tank 132.
- 60.0 Slop Oil Tank 388. No Photograph.
- 61.0 Ballast Water Tank W-12. No Photograph.
